**RCRA AK9 69033 0742**  
**Attachment 10, Appendix E - Site 6B**  
Land Use Control Implementation Plans

**U.S. Coast Guard Base Kodiak**  
**Kodiak, Alaska**

**March 2021**

## **5.0 SITE 6B – NYMAN PENINSULA FUEL FARM**

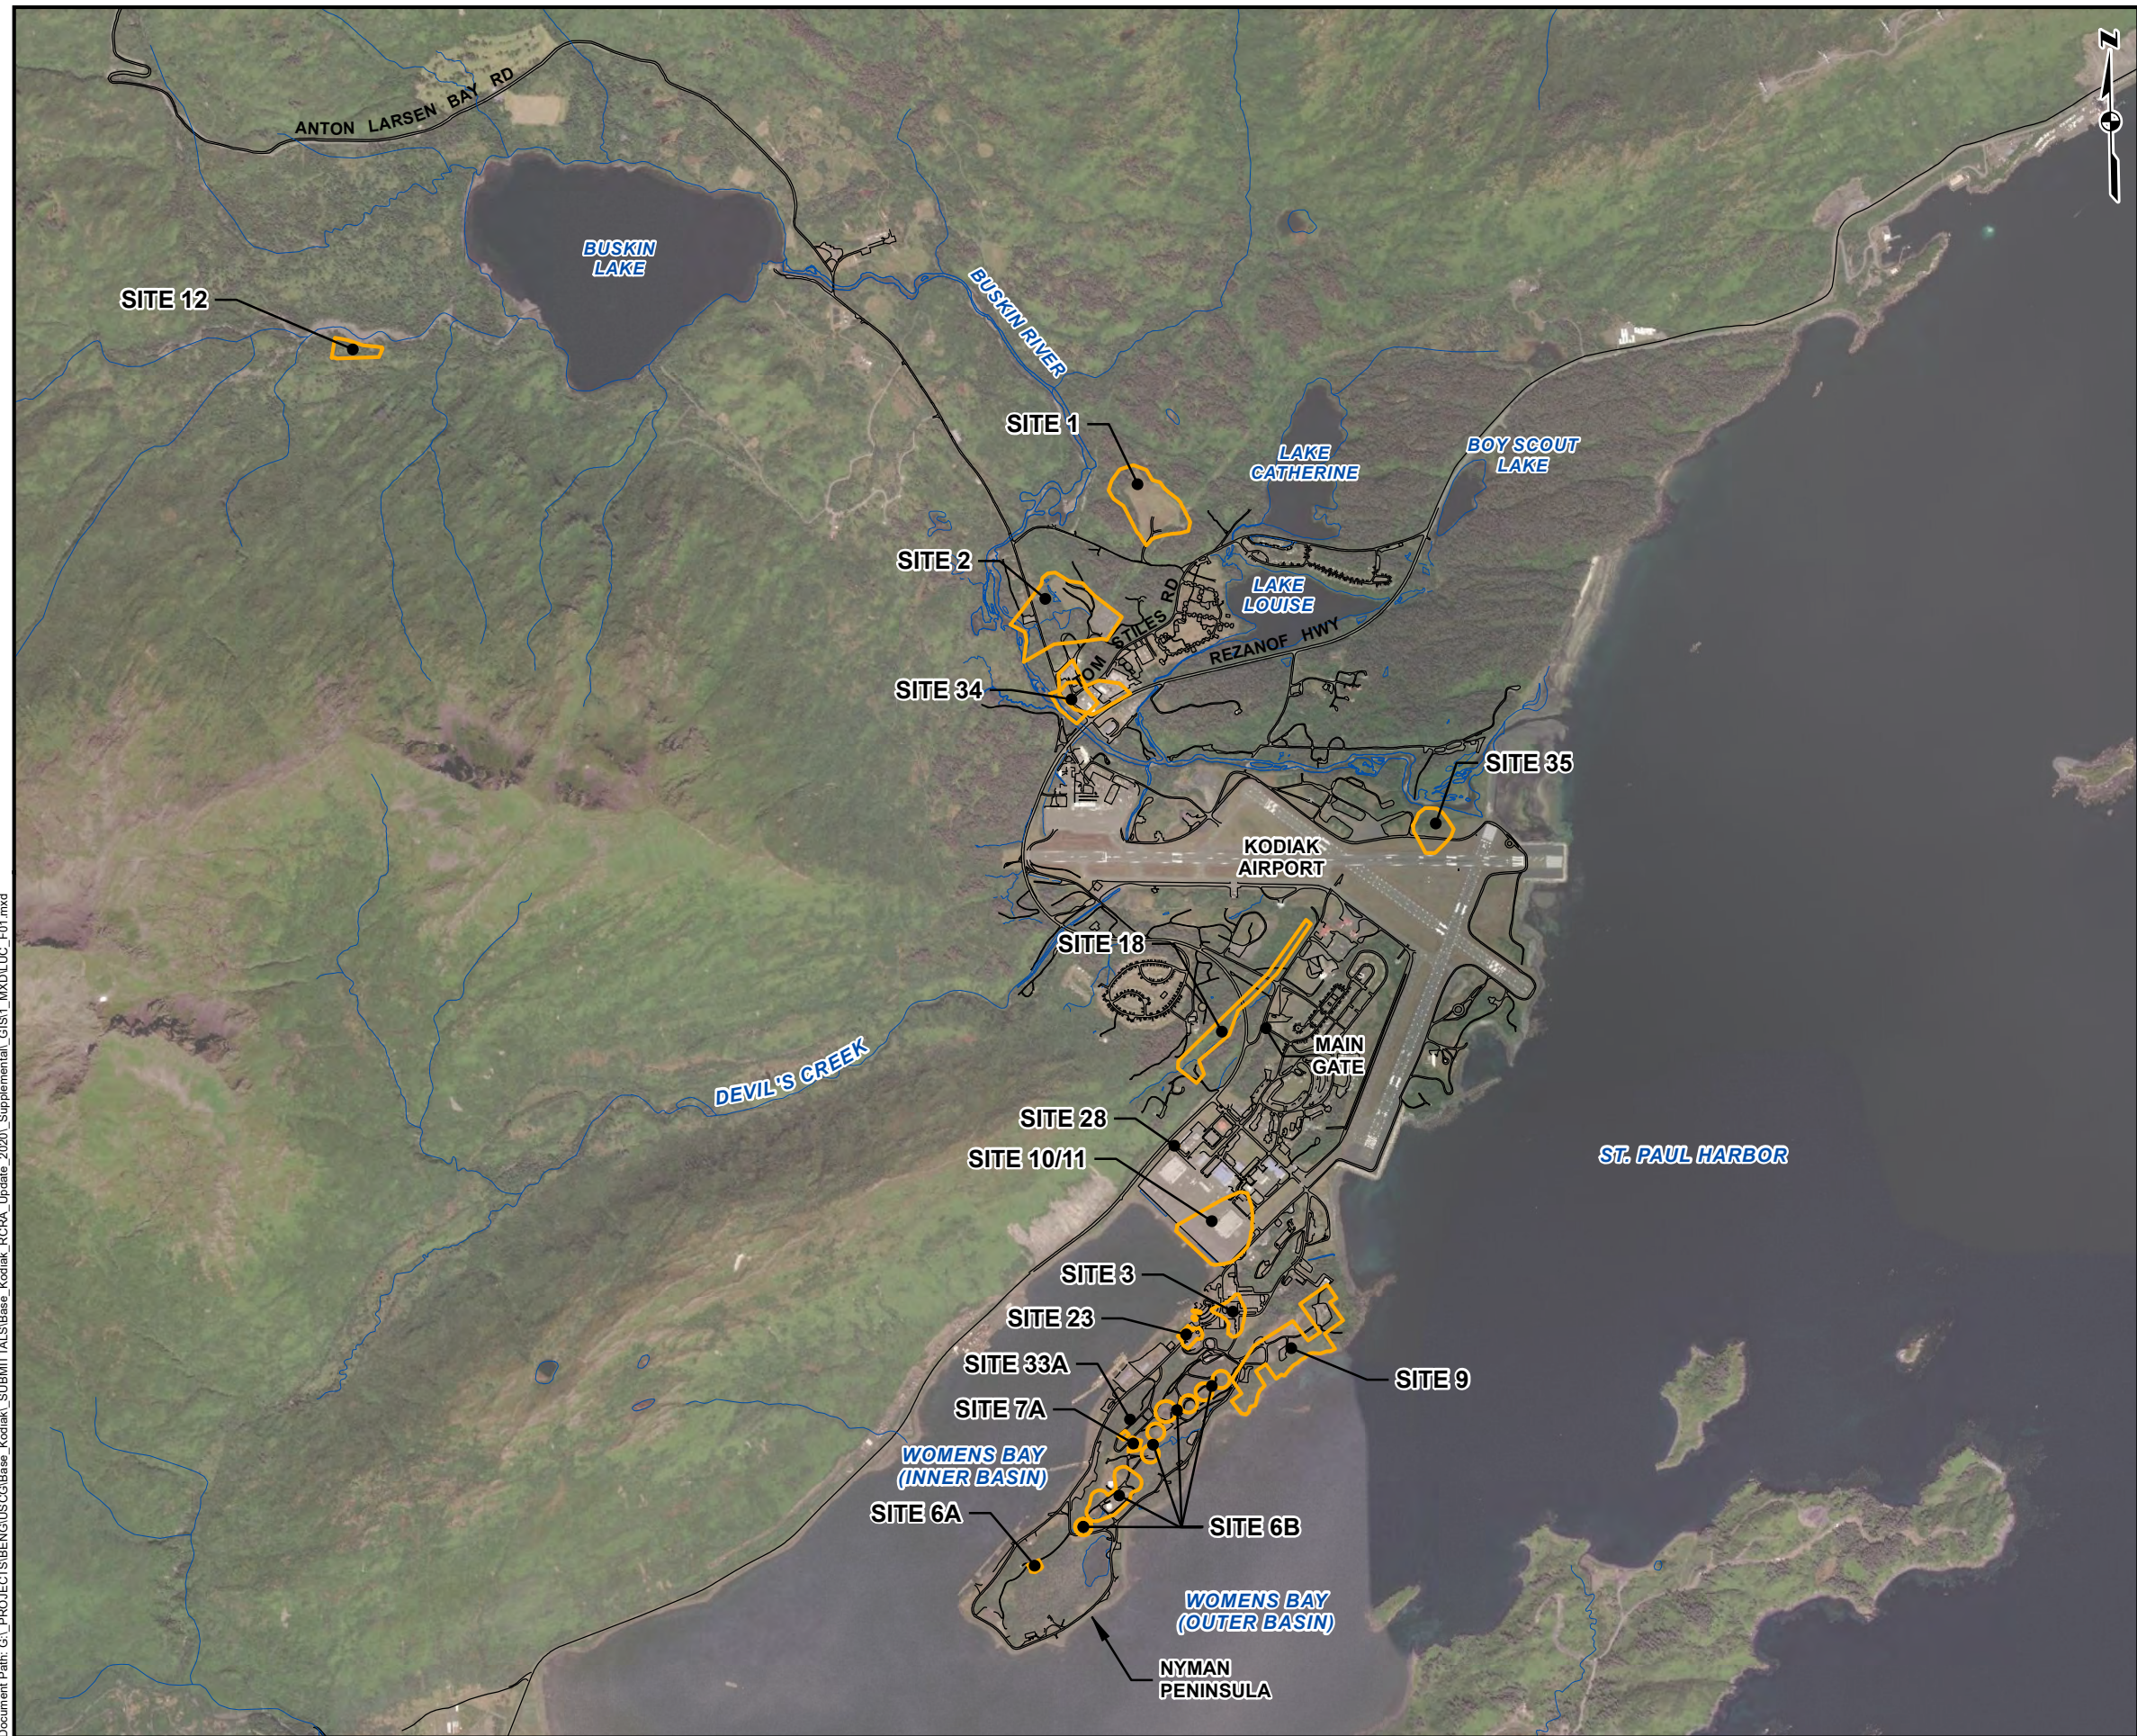
PROJECT No.: 680411	DATE: 8/20/2020	FIGURE: <b>1</b>
P.M.: CS	DRAWN: CMH

Site 6B, the Nyman Peninsula Fuel Farm (Fuel Farm), is located on the southeast side of the Base and spans the central, elevated portion of Nyman Peninsula (Figure 1).

LAND USE CONTROL IMPLEMENTATION PLAN  
USCG BASE KODIAK, KODIAK, ALASKA  
LUCAP INSPECTION SITES

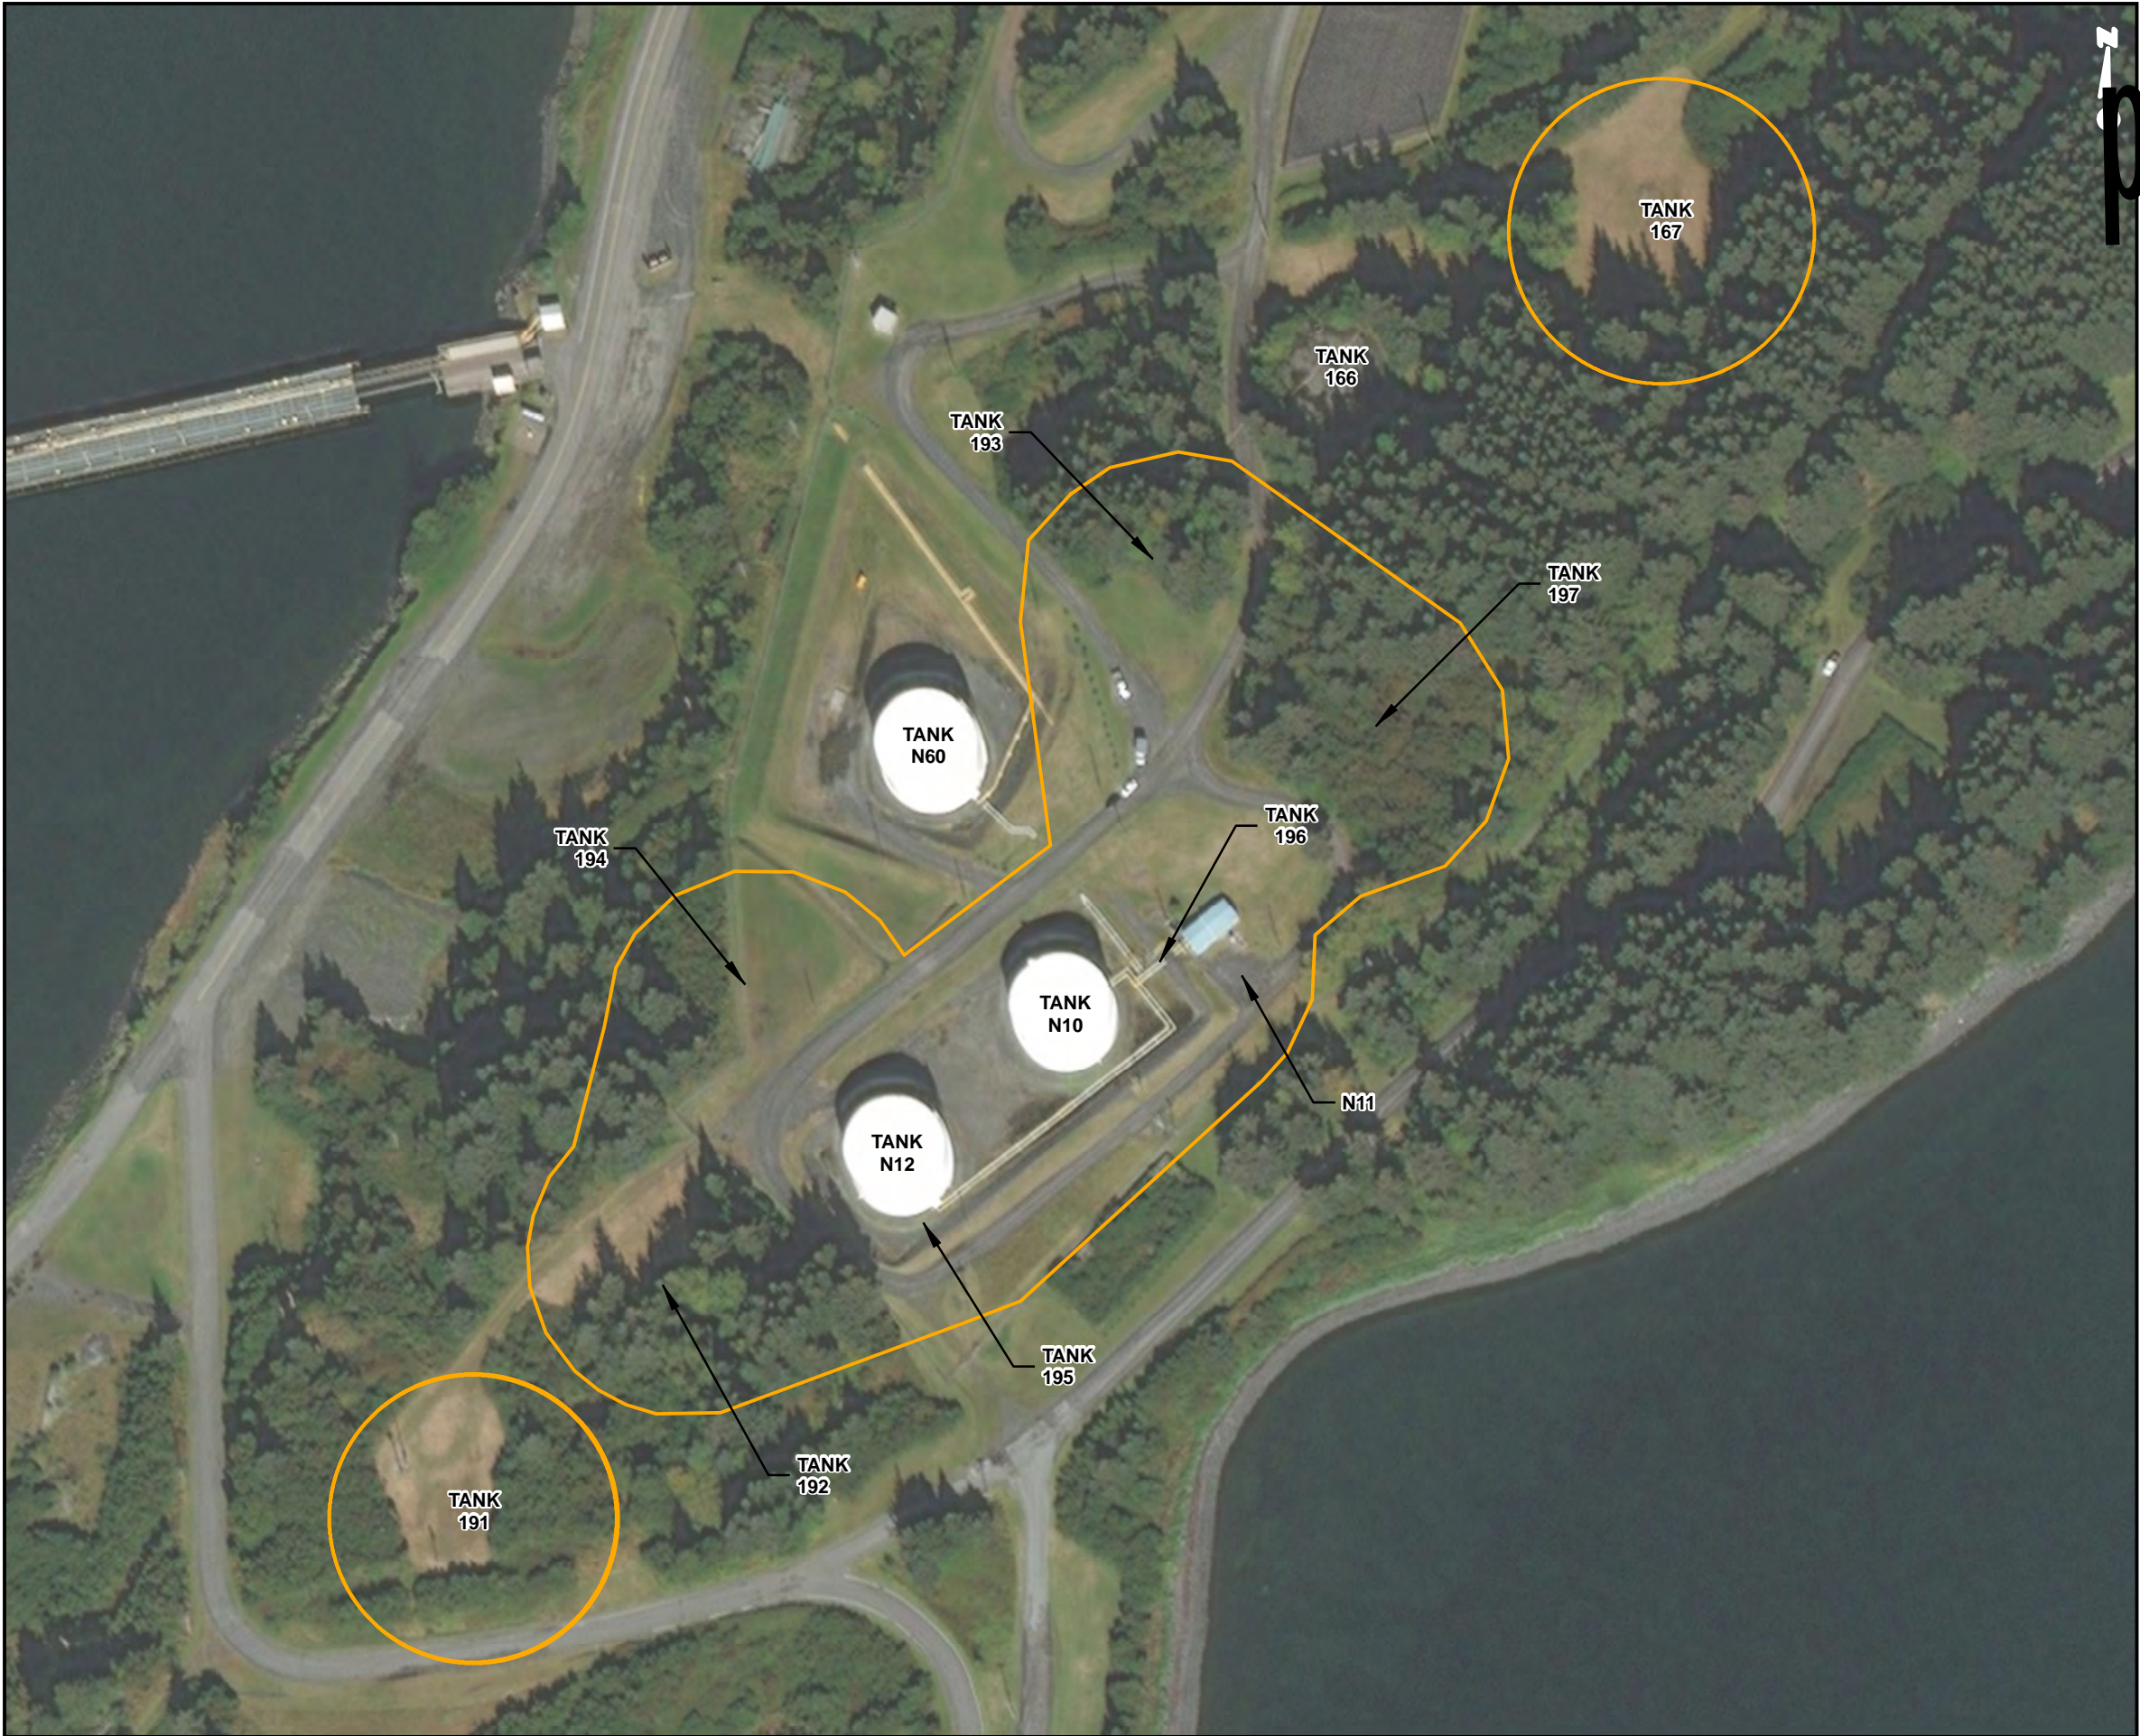
To remain protective of human health and the environment, the property is restricted to industrial use, with engineering controls in place to limit access to petroleum-contaminated soils. The areas affected by these restrictions are shown on Figures 6 and 7.

During World War Two (WWII), the U.S. Navy established a base on Kodiak Island to protect the Gulf of Alaska and serve as an intermediate point between installations at Cold Bay and Sitka. The Fuel Farm has been the major bulk storage facility at the Base since the original construction of the Naval Station. The Fuel Farm consists of several areas (Figures 6 and 7):

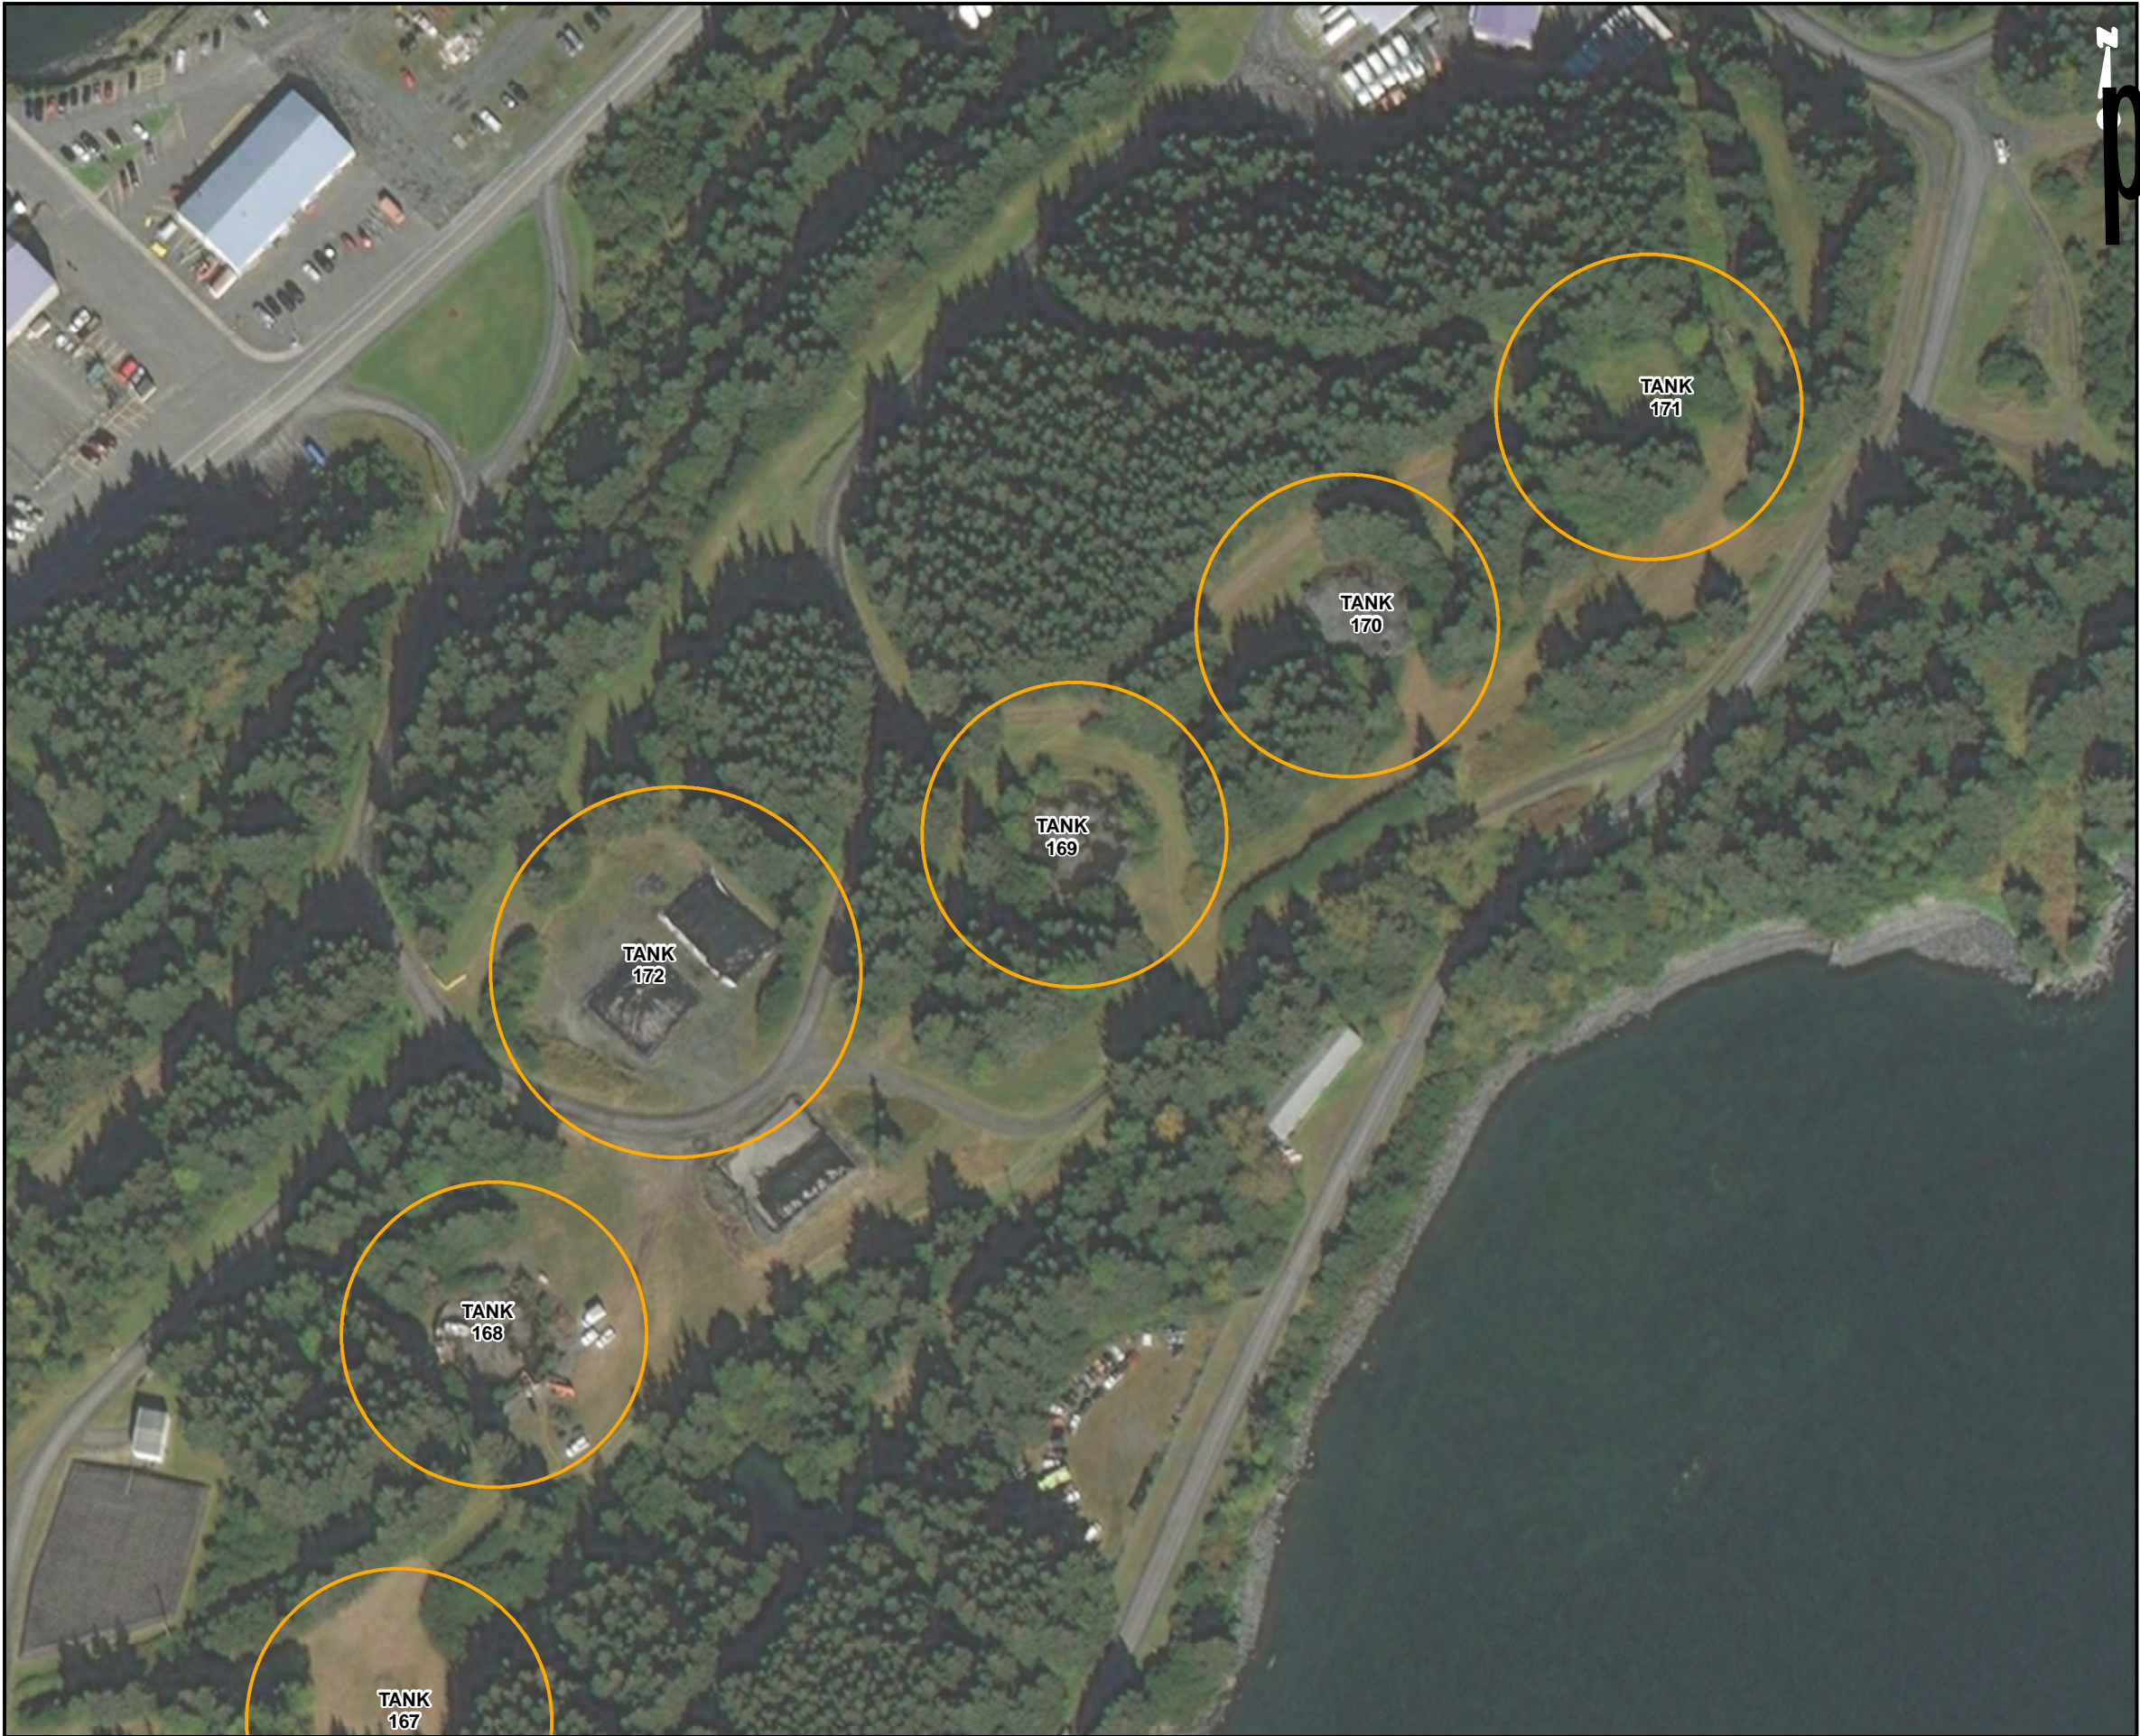
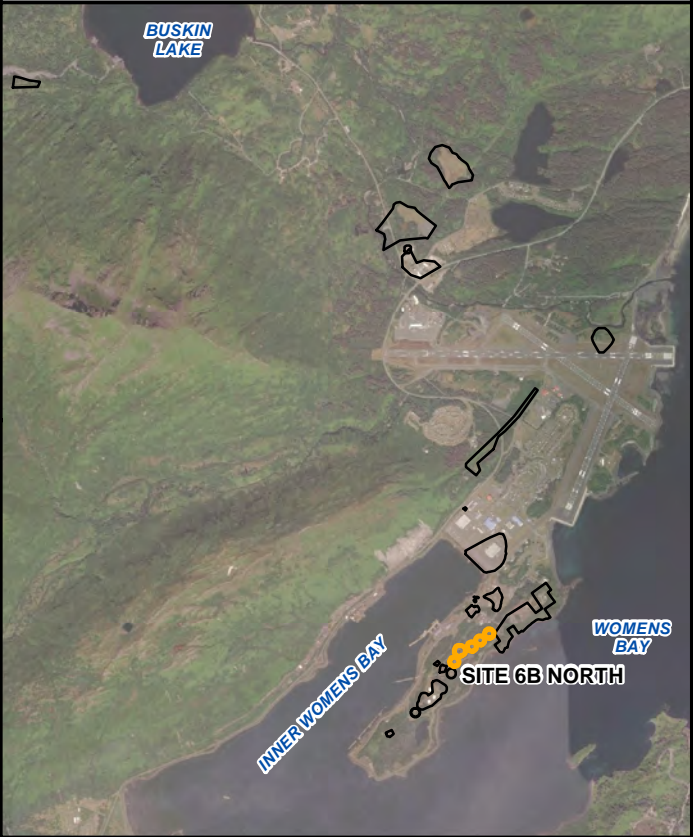
PROJECT No.: 680411	DATE: 9/15/2020	FIGURE: <b>7</b>
P.M.: CS	DRAWN: JC

LAND USE CONTROL IMPLEMENTATION PLAN  
USCG BASE KODIAK, KODIAK, ALASKA  
**SITE 6B**
